NOT JUST ANOTHER DAY AT THE BEACH

CASE STUDY: DOCKSIDE CONDOMINIUMS

Constructed in 1978, Dockside Condominiums is a 19-story residential reinforced concrete structure on the bank of the Charleston Harbor in South Carolina. As one of the last high-rise buildings constructed in Charleston prior to city-imposed height restrictions, preservation of the structure is of utmost importance to its residents.

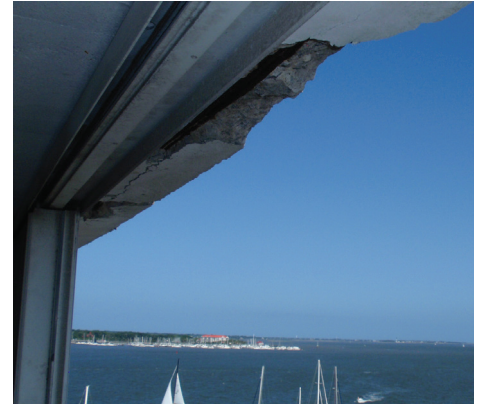
Corrosion-related distress and deterioration were identified at reinforced concrete balconies and walls, and in the post-tensioned concrete parking deck located under the building during earlier surveys. As the concrete distress progressed, loose concrete pieces fell from balcony nosings and parking garage ceilings. The condominium homeowners realized the need to remedy the falling

Slab edge distress and overhead spalling hazards prior to repair

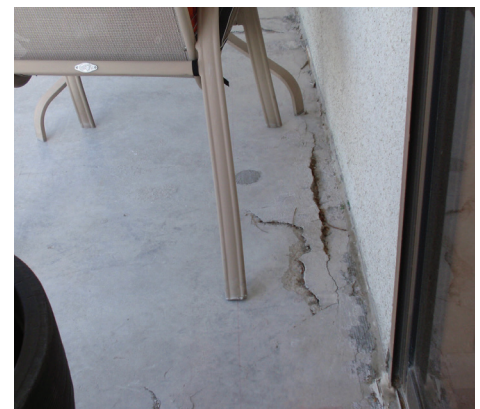
Reinforcing steel corrosion and concrete distress at balconies prior to repair

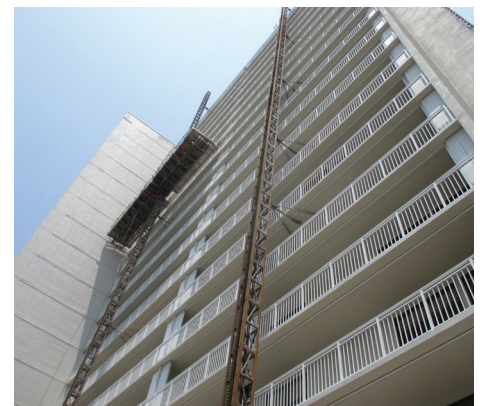
Mast climbers used to access balconies for repairs

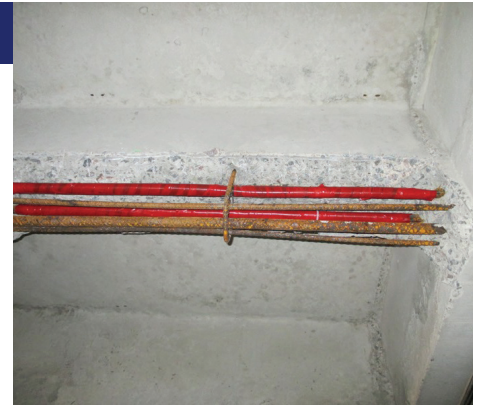
Post-tensioned beam repairs in progress

and concrete repair materials to ensure compatibility with the ICCP system, and for addressing identified hazardous materials. Repairs were conducted on post-tensioned concrete in the parking garage prior to installation of thermal spray GCP.

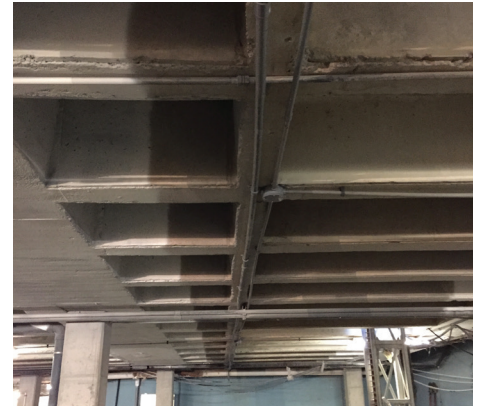
Thermal spray cathodic protection by the System Provider at garage components under the building

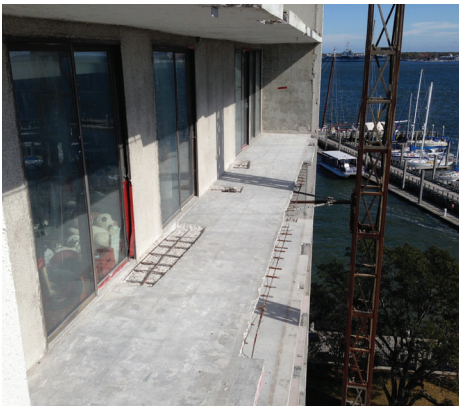
Concrete repairs in progress at balconies

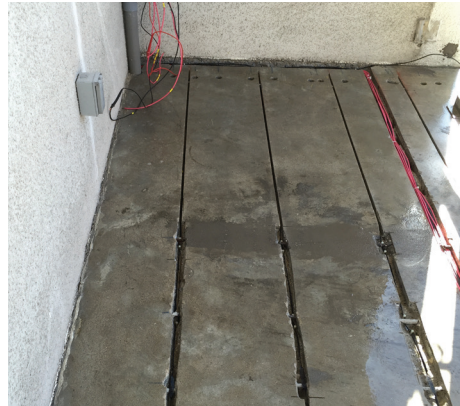
Impressed cathodic protection system installation in progress at balconies

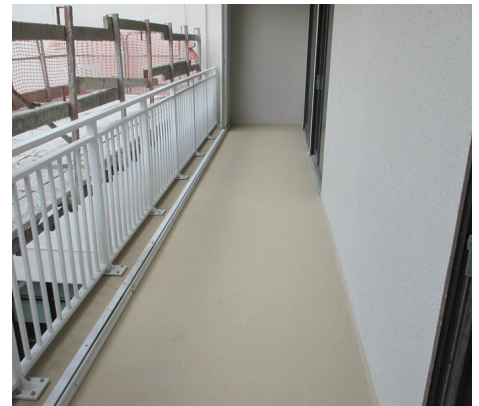
Finished balcony showing new guard rails, completed repairs and new deck coatings
